Roofs

APPROPRIATE TREATMENT GUIDE

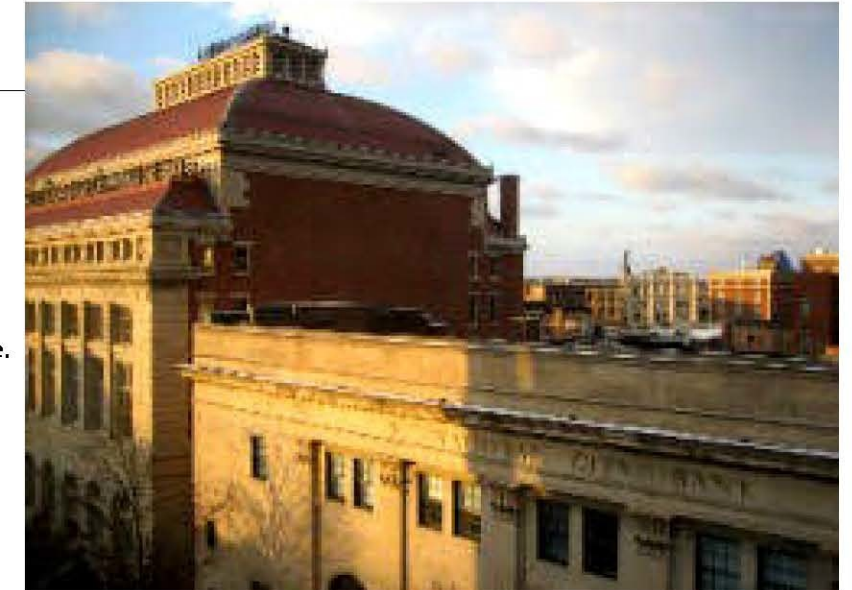
The terra cotta tile roof of the Troy Savings Bank Music Hall is perhaps the most iconic roof in Troy.

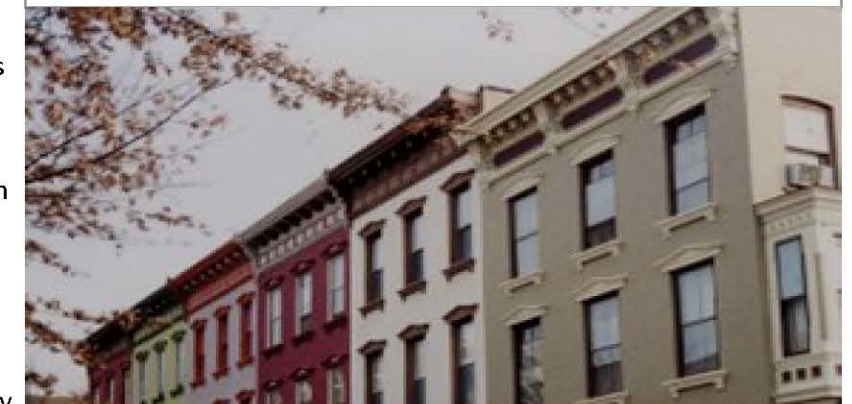
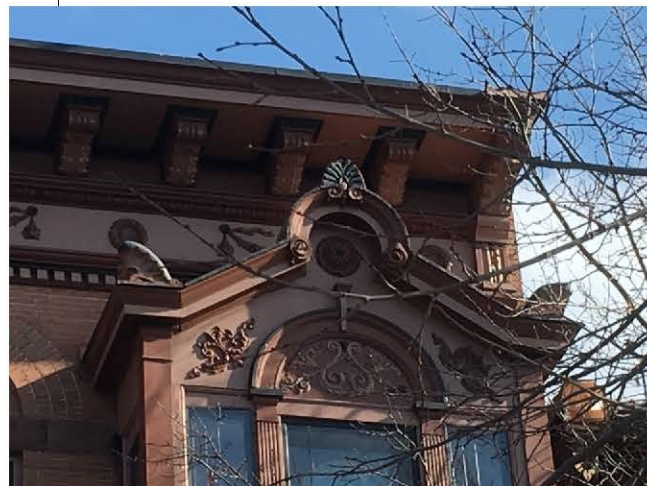
Bays and porticos often have decorative roofs.
